ADVANCE REPORT
on the
SEDIMENTATION SURVEY OF MISSION LAKE
HORTON, KANSAS

April 15 to May 6, 1937

Sedimentation Studies
Division of Research
SCS-SS-22
July, 1938

ADVANCE REPORT ON THE
SEDIMENTATION SURVEY OF MISSION LAKE

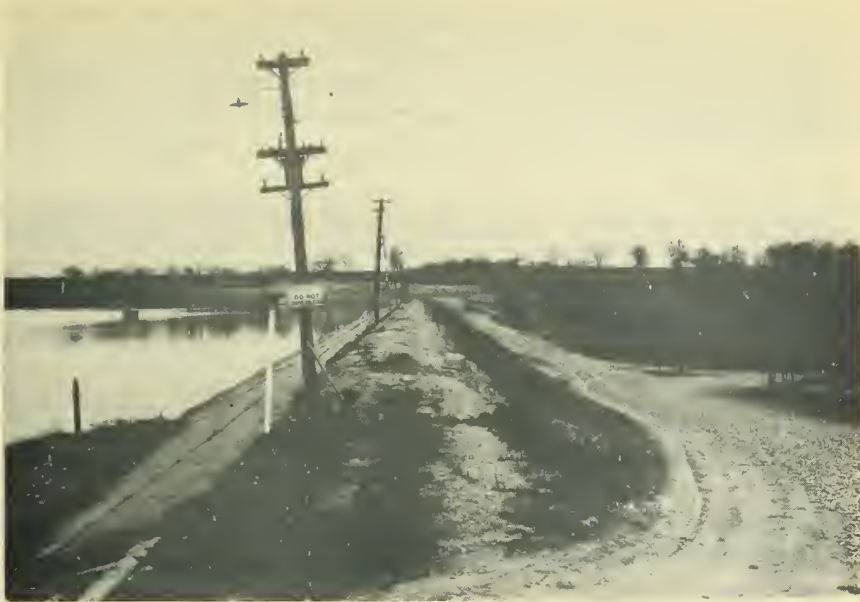
Description of dam: Mission Lake dam (fig. 2) has a total length of 1,170 feet and extends in a northwest direction across Mission Creek Valley. It is an earth-fill structure with a maximum height of 34 feet and top and bottom widths of 10 feet and 145 feet, respectively. The earthen embankment is made watertight by a puddled core extending from crest level to the natural valley bottom and Wakefield wooden sheet piling extending to bedrock. The upstream face is covered with 6-inch reinforced concrete slab with expansion joints at 25-foot intervals, and has a slope of 3:1. The downstream face has a slope of 2:1.

.Figure 2.--View of the dam of Mission Lake from the west end.

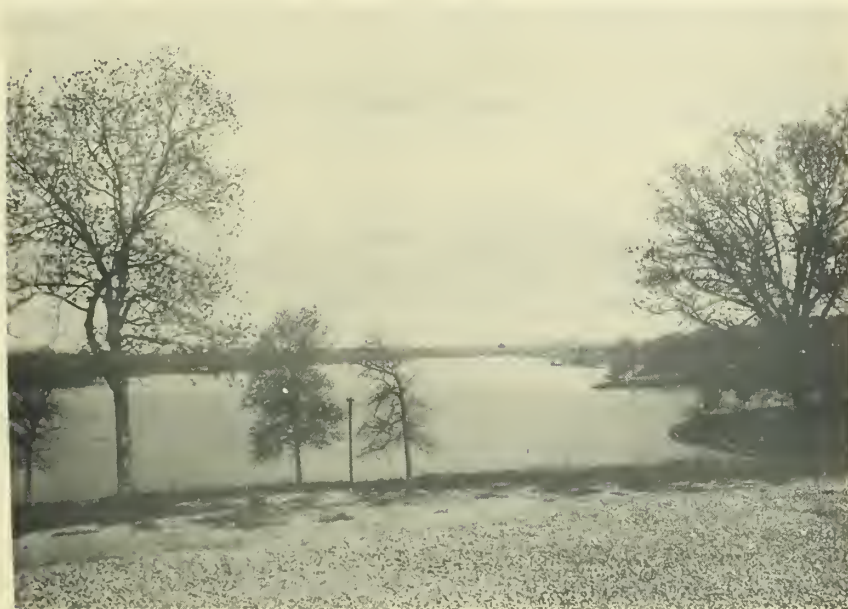
Figure 3.--View along the east shore of Mission Lake from the dam, showing rock riprap.

Submerged slopes are in general moderately steep, and descend about 14 feet from crest level to the valley bottom within a horizontal distance of 200 feet. A riprap of loose rock, extending 2.5 feet below and 1 foot above crest, has been placed along the shore line of the lower part of the lake to prevent wave erosion (fig. 3).

Littoral zones, including wave-cut banks 1 to 4 feet in height just above crest and thin gravel and sand terraces below crest, have formed along approximately 40 percent of the shore line below range R16-R17. In a few places this has occurred in spite of a protective riprap of loose rock and concrete blocks along the shore.

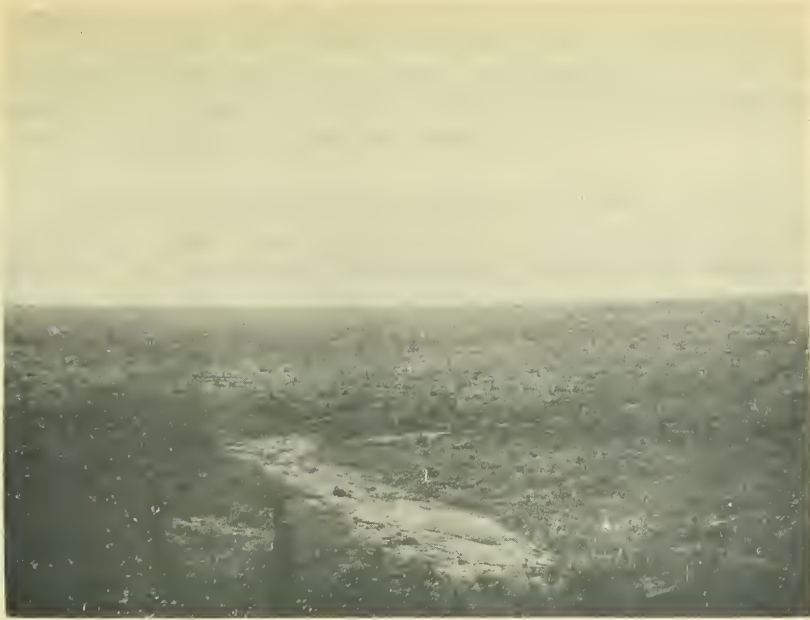
Erosion conditions: Erosion far in excess of the normal rate is occurring in many areas within one mile of the lake. Numerous small gullies have developed on the cultivated slopes, and their headward growth is rapid in the soft loess and loess-derived soils. The gullies are most numerous and active in the east half of sections 21 and 28 near the lake shores.

Sheet erosion is also removing large quantities of soil in sections 21 and 28 (Fig. 6) as well as in most cultivated areas farther from the reservoir where gully development is not so serious. Soil-conservation practices have not yet come into general use in the drainage basin.

Figure 6.—Erosion on cultivated slope near Mission Lake dam.

Gully-control measures around the lake and a scientific erosion-control program throughout the drainage area are needed if the productivity of the land is to be maintained and the utility and beauty of the reservoir preserved. The success of such a program would be measured by the degree of cooperation between the city of Horton and farmers within the watershed in their efforts to protect the lands from erosion and the reservoir from excessive sedimentation.

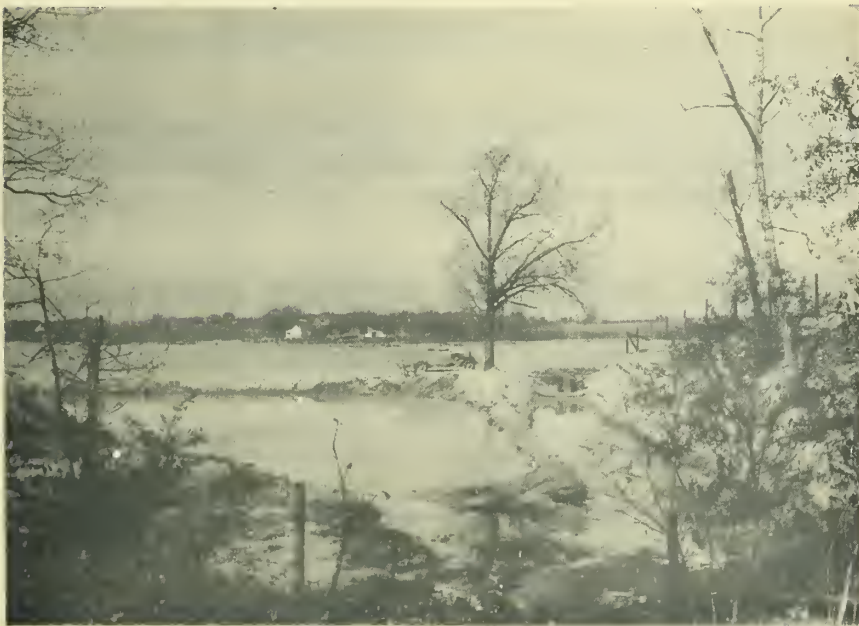
Figure 7.—Silt trap or settling basin behind road fill on east side of Mission Lake.

Estimates of the amount of sediment in the small silt-trap basins behind the road fills around the lake (fig. 7) were made during the course of the survey.

An estimated total of 2.32 acre-feet of sediment has accumulated in the check basins behind the road fills. In the absence of the silt traps nearly all of this sediment would have been deposited in the reservoir basin. Figure 7, (following p. 7) illustrates one of the road-fill basins on the east side of the lake.

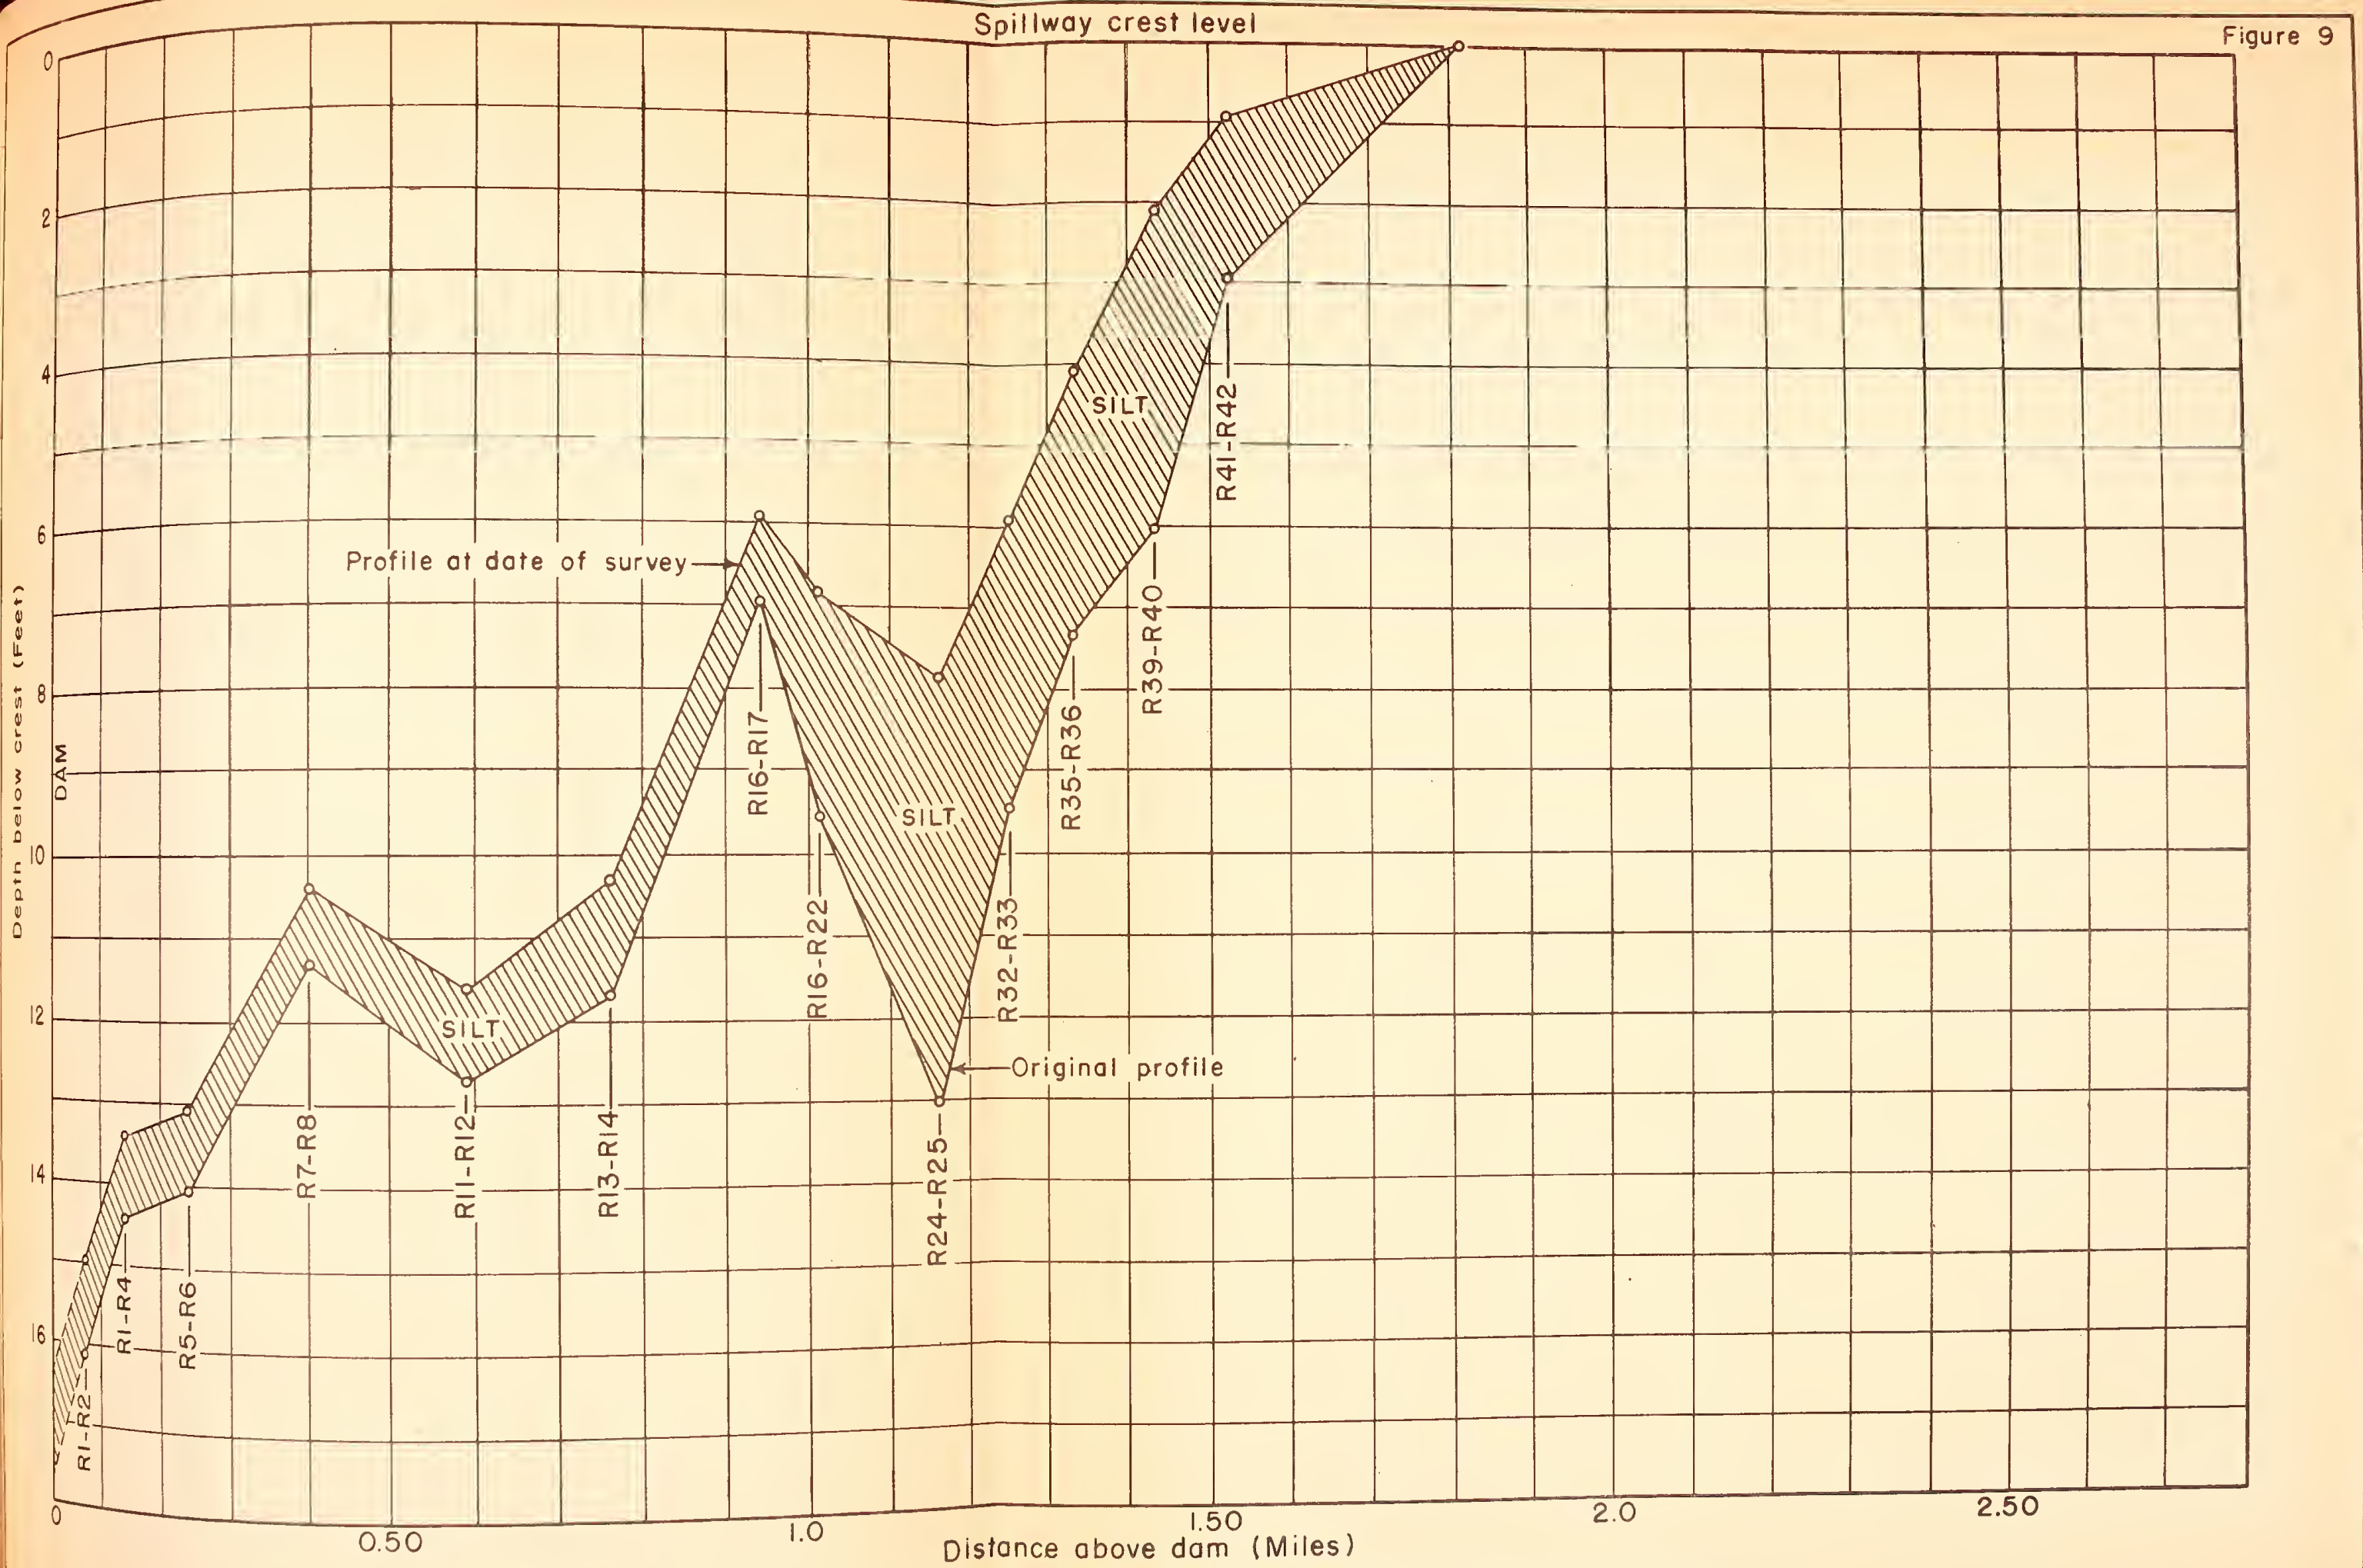
FIGURE 9. Average-depth profiles, Mission Lake, Horton, Kansas.

The general distribution of sediment is illustrated in figure 9. The thickest deposits have accumulated in the lower portions of the main tributary arms in segments 16, 17, 18, 21, 22, 23, and 25 (fig. 4). In this area the currents of water entering the wider portion of the lake from the smaller arms encounter deeper water and are sharply retarded, with resulting deposition of much suspended

sediment. The sediment thicknesses in segments 16, 17, and 18 illustrate this effect. On ranges R26-R27 and R28-R29 the maximum thickness of sediment in the channel is approximately 10 feet, and the average thickness on the 2 ranges is nearly 6 feet. On range R23-R24 the maximum and average thicknesses are 8 feet and 2.4 feet, respectively. The original stream channel has been completely filled in this part of the reservoir. Comparable deposits have accumulated in all the other important arms above segment 11.

Measurements on range R13-R14 in the upper part of the main lake showed a maximum sediment thickness of 5.9 feet in the channel beneath 18 feet of water and an average thickness of 2.6 feet on the flatter portions of the bottom beneath an average water depth of 14.5 feet. Below range R13-R14, maximum thicknesses in the channel range from 3.6 to 5.6 feet, but the sediment on the flatter portions of the bottom becomes considerably thinner toward the dam.
